# A Transect Walk

to observe water and sanitation infrastructure  
undertaken in the rural municipality San Andrés  
de Tupicocha in the Peruvian Andes

2020

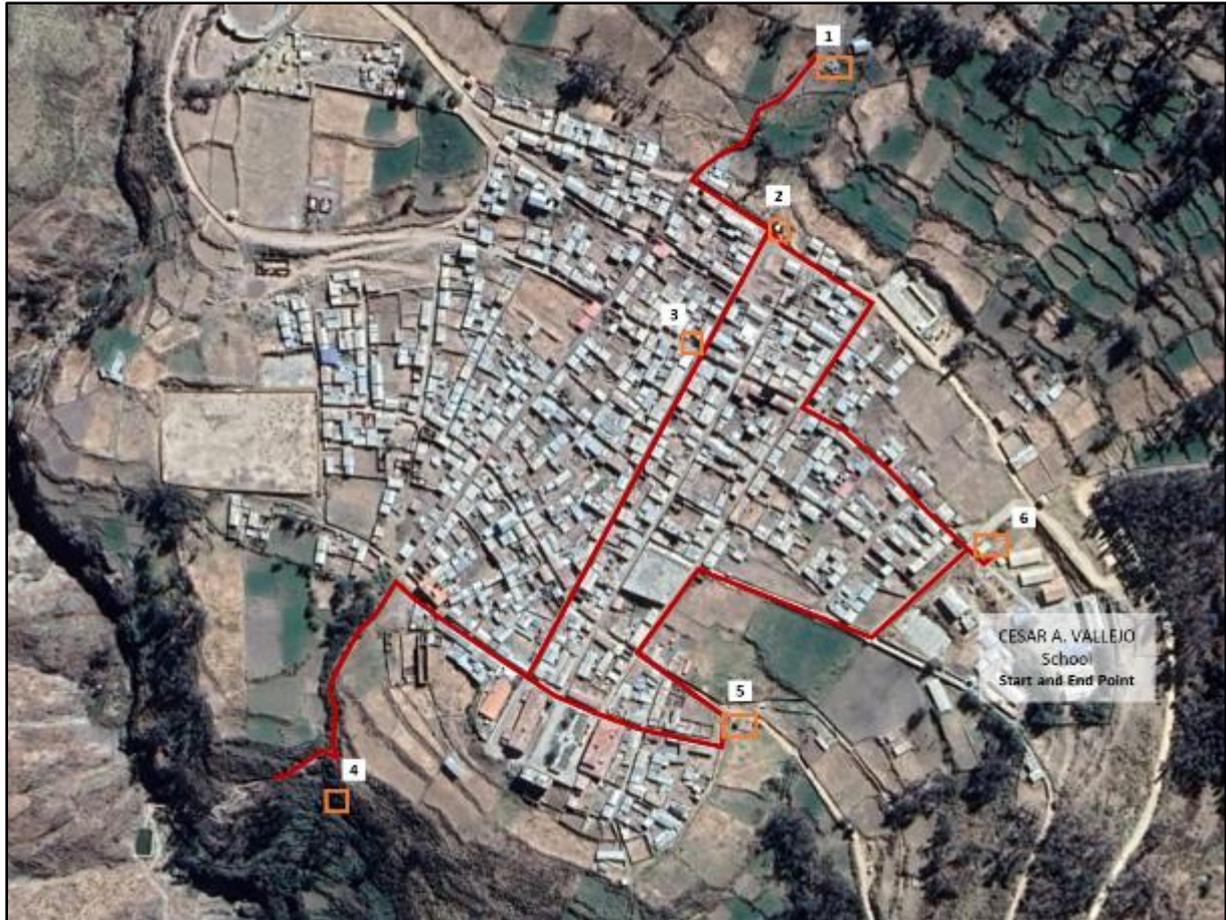
Figure 1: Route of the transect walk in the village of San Andrés de Tupicocha; (Source: Google earth - Accessed 20.07.2020)

The route of the transect walk led to six pre-selected locations (see Figure 1). First stop - main water tank of Tupicocha; second stop - public toilets in Tupicocha; third stop - shaft for pressure reduction; fourth stop - wastewater effluent; fifth stop - pond; and sixth stop - school toilets.

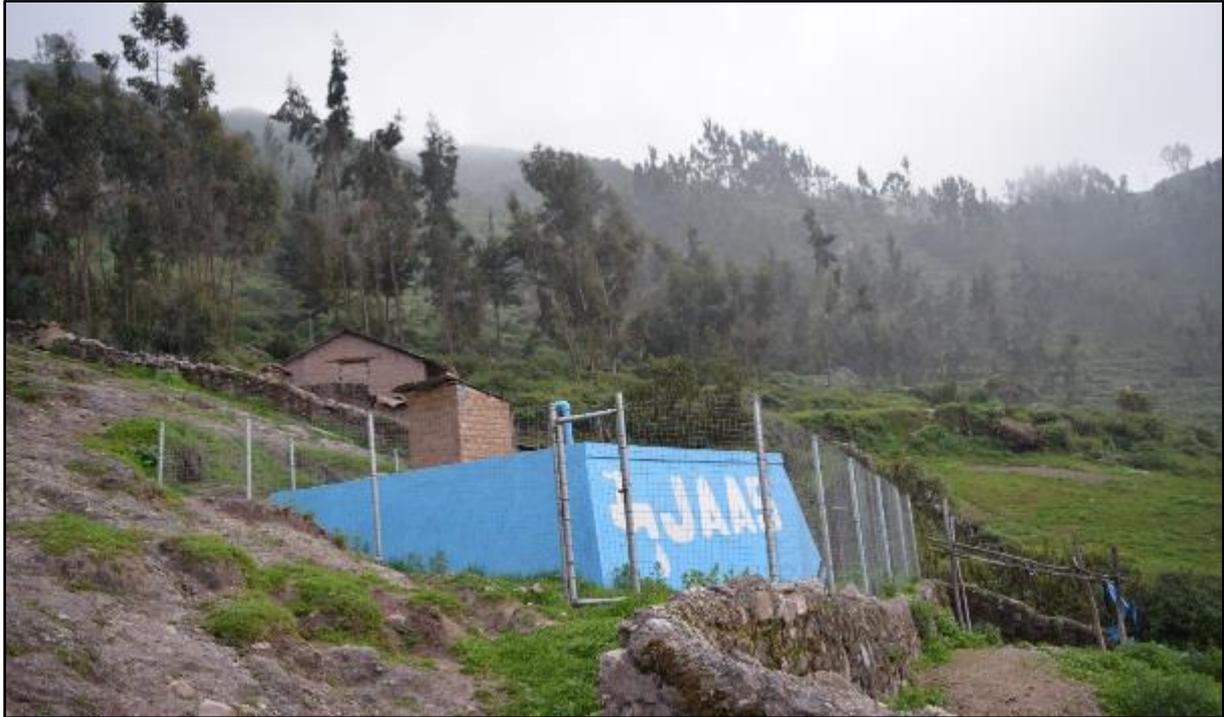
*Figure 2: Inspection point 1 - Main water tank*

The first inspection point was the water tank in Tupicocha (Figure 2). On the way to the tank, students and teachers were instructed to observe the environment and to note any noticeable aspects regarding the drinking water and sewage situation in the village. Arriving at the drinking water tank, safety precautions such as fencing and chlorination as well as other components of the tank were discussed.

**Inspection point 1:** The main water tank is secured with surrounding fences, which offer a protection from trespassers and animals. The existing chlorination infrastructure could contribute to a better drinking water quality but does not guarantee for safe drinking water as parasites cannot be removed with chlorination. The chlorination unit is not working throughout the year. Directly next to the water tank there is a building for livestock. Small insects could enter into the tank through the ventilation. Overall of the tank appeared to be not accessible for other animals.

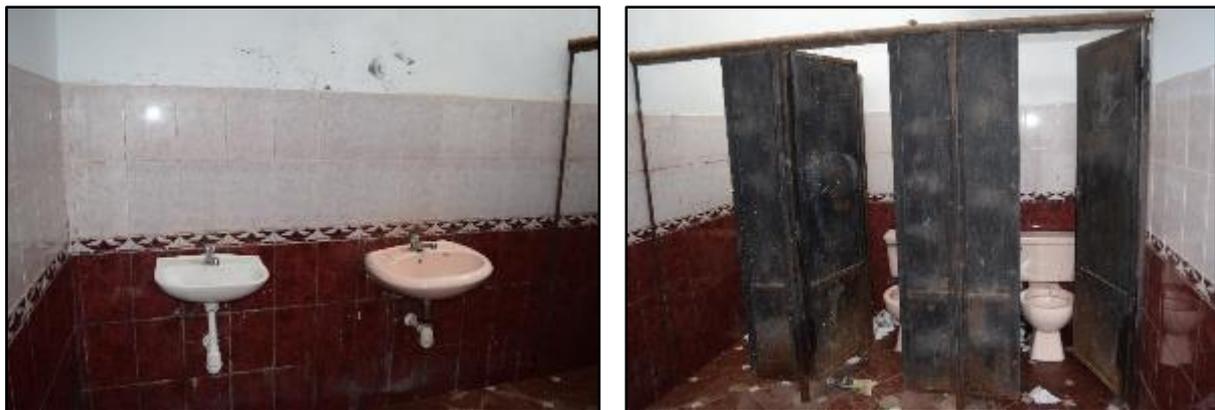
*Figure 3: Inspection point 2 - Public toilets*

After the inspection of the water tank, the public toilets (Figure 3) close to a bus stop located below the tank, were inspected. For this location a questionnaire was prepared for the students to help them to note their observations. The female students inspected the women's toilet and the male students the men's toilet. Additionally, the questionnaires contained questions to describe the sanitary situation at their homes.

Inspection point 2: The public toilets have a water connection and are connected to the canalization. But privacy requirements are not given, because some doors were missing, or locks didn't exist or did not work. Also, cleanness was unsatisfactory for the students. Hand wash facilities existed, but without water and soap.

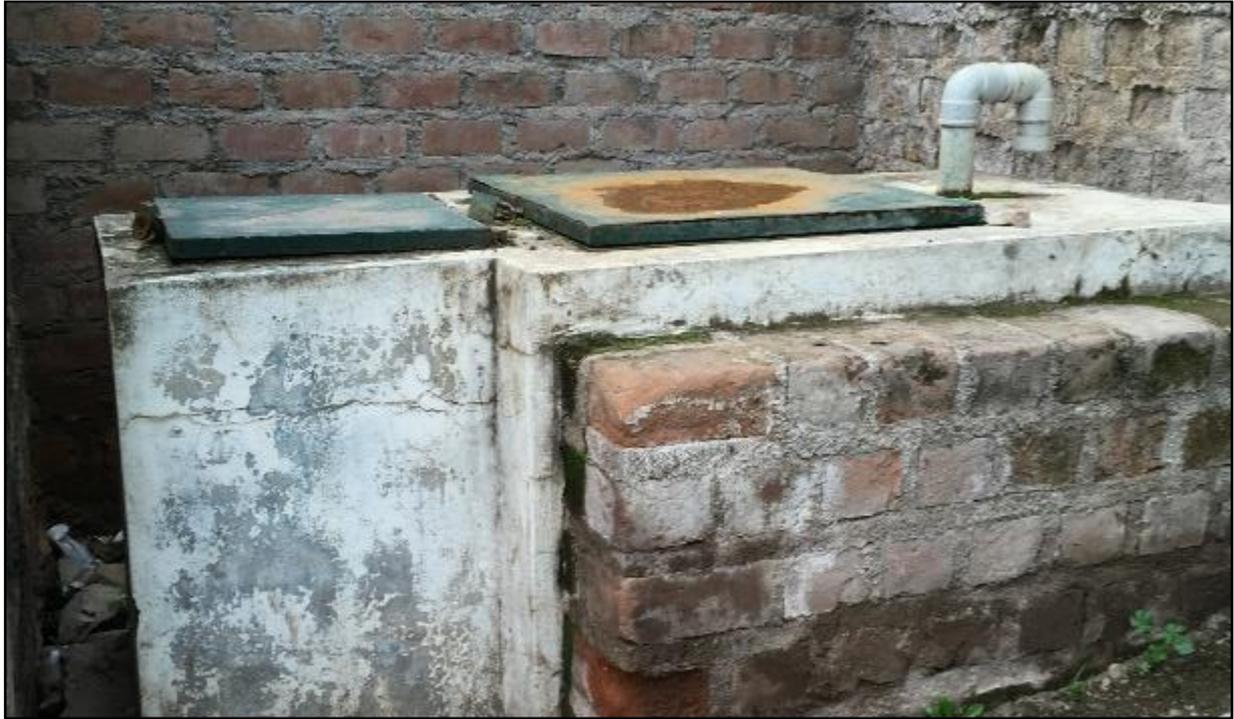
*Figure 4: Inspection point 3 - Pressure reduction shaft*

The third stop was an intermediate shaft for pressure reduction (Figure 4). The environment and existing protection measures were discussed.

Inspection point 3: The water pressure chamber is used to lower the pressure in the delivery pipes. The tank is accessible for humans and animals. The lid of the tank was locked. Garbage and empty beer bottles could be found around the tank. The aeration of the tank is closed with a tap. Insects could enter the tank through the aeration, but no other animals.

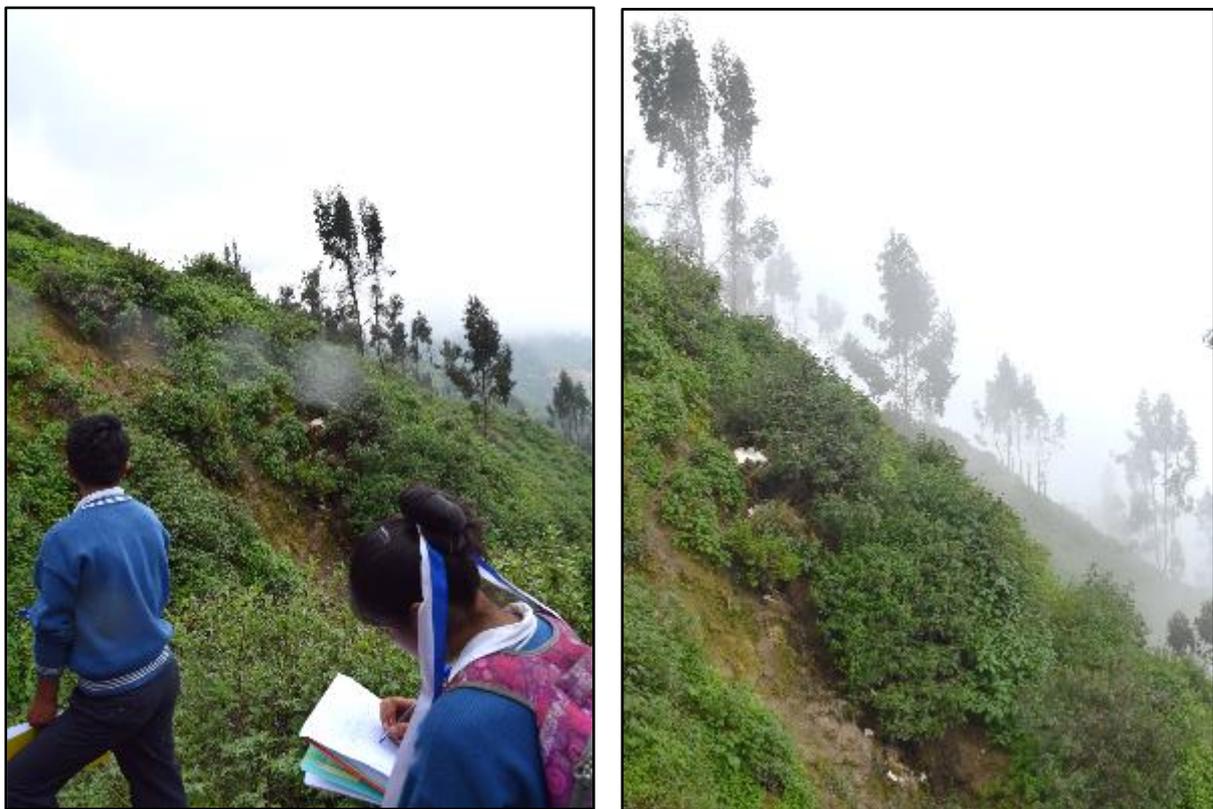
*Figure 5: Inspection point 4 – Wastewater effluent*

The fourth stop was the discharge point of wastewater into a nearby stream located below the village (Figure 5). During the inspection foam formations were observed at the wastewater outlet. Both origin and destination of the wastewater were discussed.

Inspection point 4: The wastewater discharges without treatment into the stream. Two wastewater flows could be identified at this spot. One hidden under bushes (domestic wastewater), another one further above (wastewater from the local slaughterhouse). Further below the discharge point, the stream is used for irrigation, posing a potential health risk.

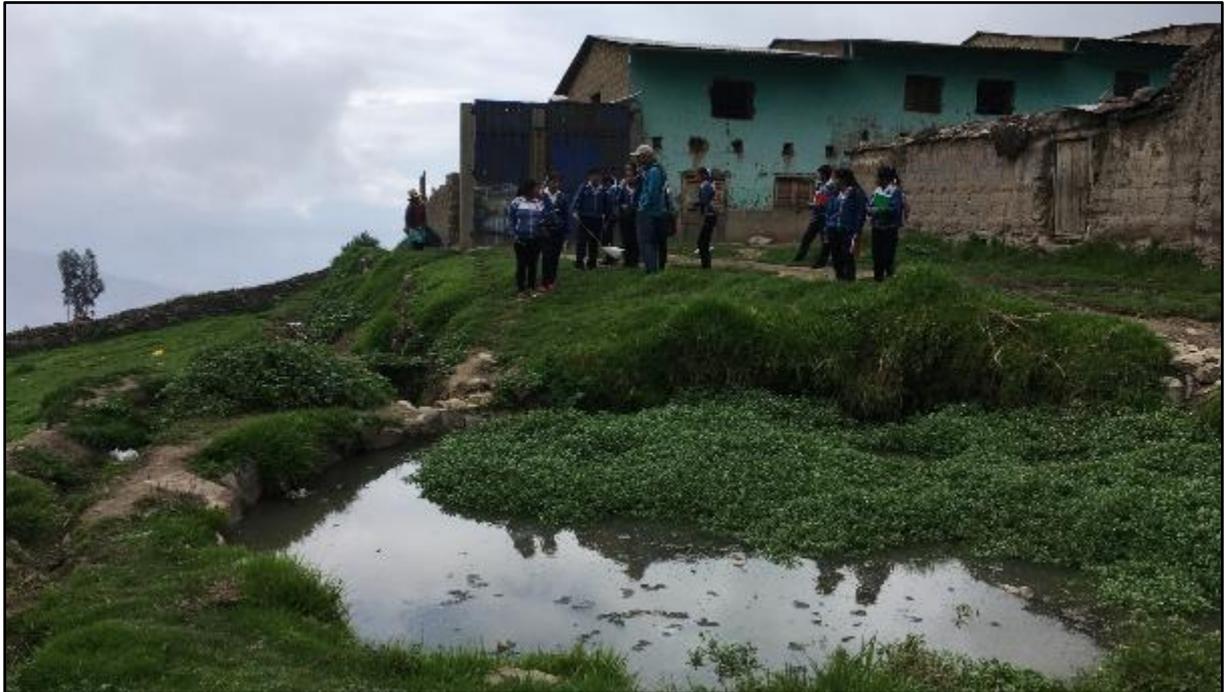
*Figure 6: Inspection point 5 - Water pond*

The fifth stop was at a small pond. The water collected there is used by local farmers to irrigate the surrounding fields. One of the most striking features of the water was its appearance, high turbidity and its unpleasant odor.

Inspection point 5: It appears that wastewater can enter the pond by seepage. Therefore, the water source could be contaminated. It is later used for irrigation also posing a potential health risk.

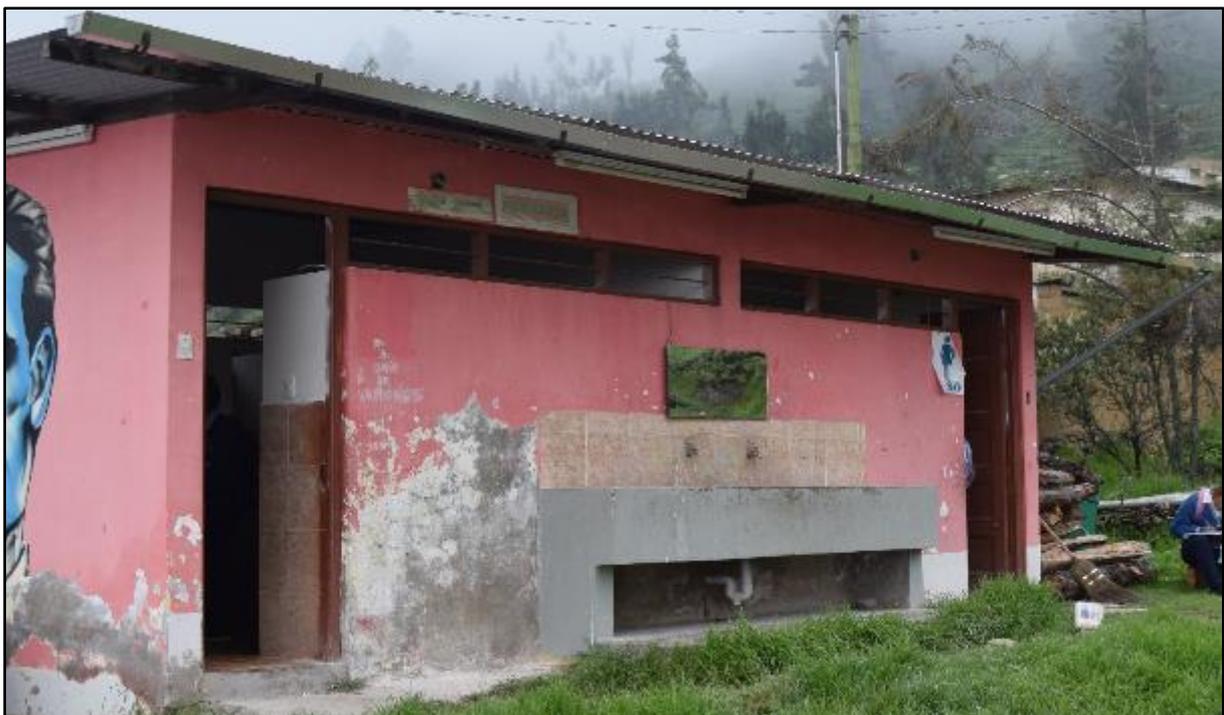
*Figure 7: Inspection point 6 - School toilets*

The last station was the inspection of the school toilets (Figure 7). Here questionnaires were also distributed to collect the necessary information regarding sanitation and hygiene.

Inspection point 6: The school toilets provided adequate privacy, they are separated by gender and had bins and doors with working locks. Outside of the building a handwashing facility existed with running water, but no soap was available.

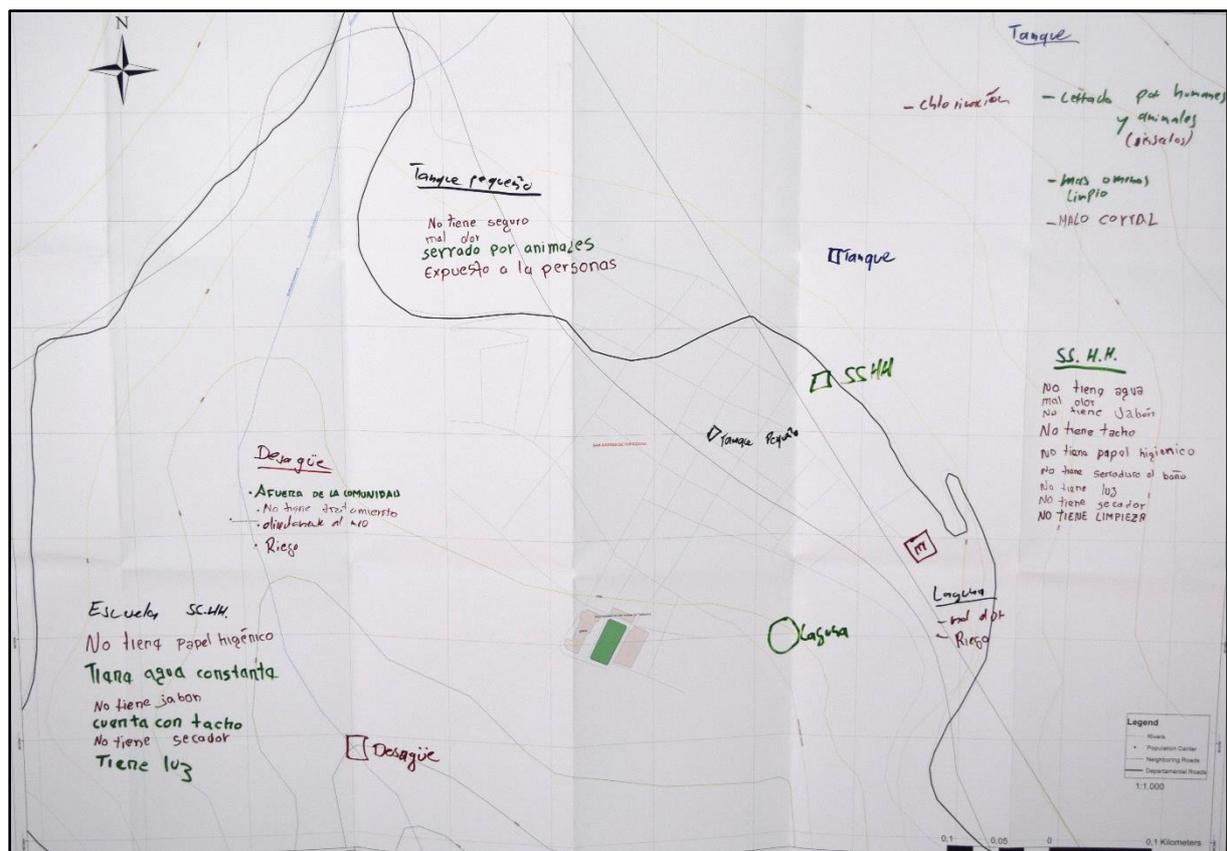
Figure 8: Transect walk results map

During the walk, visual information was collected and further information was provided by the participants. The following results are derived from these observations and discussions. Figure 8 shows the results collected by the students, summarized after the walk on a map of Tupicocha.

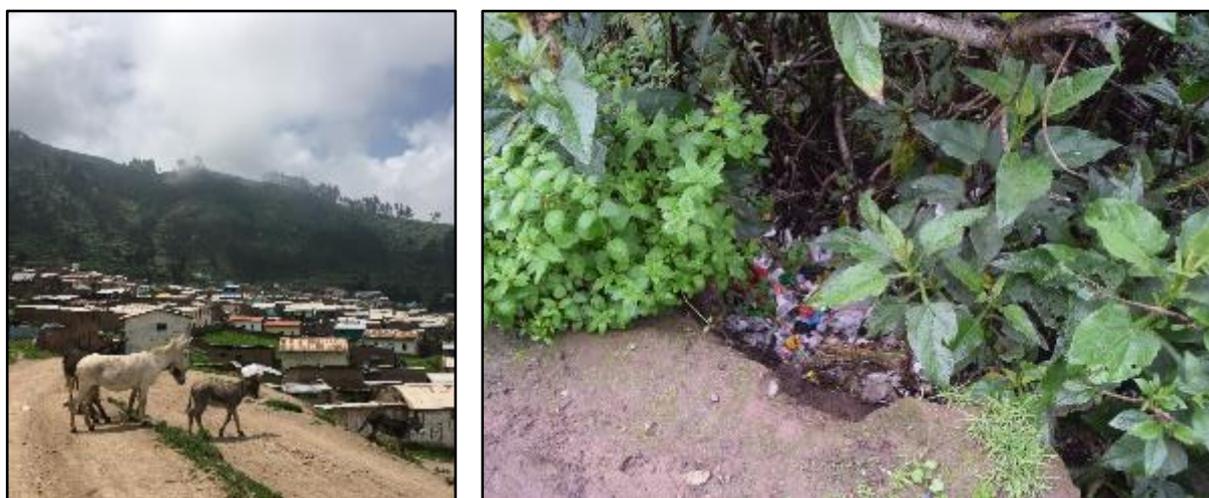
Figure 9: Additional observations

Additional information: During the walk animal excreta was observed nearly everywhere in the nonpaved streets. Furthermore, locally domestic waste dumped in the environment and bones of dead animals were observed (Figure 9). This represents a potential health risk, especially because free running dogs may carry pathogens into the houses.

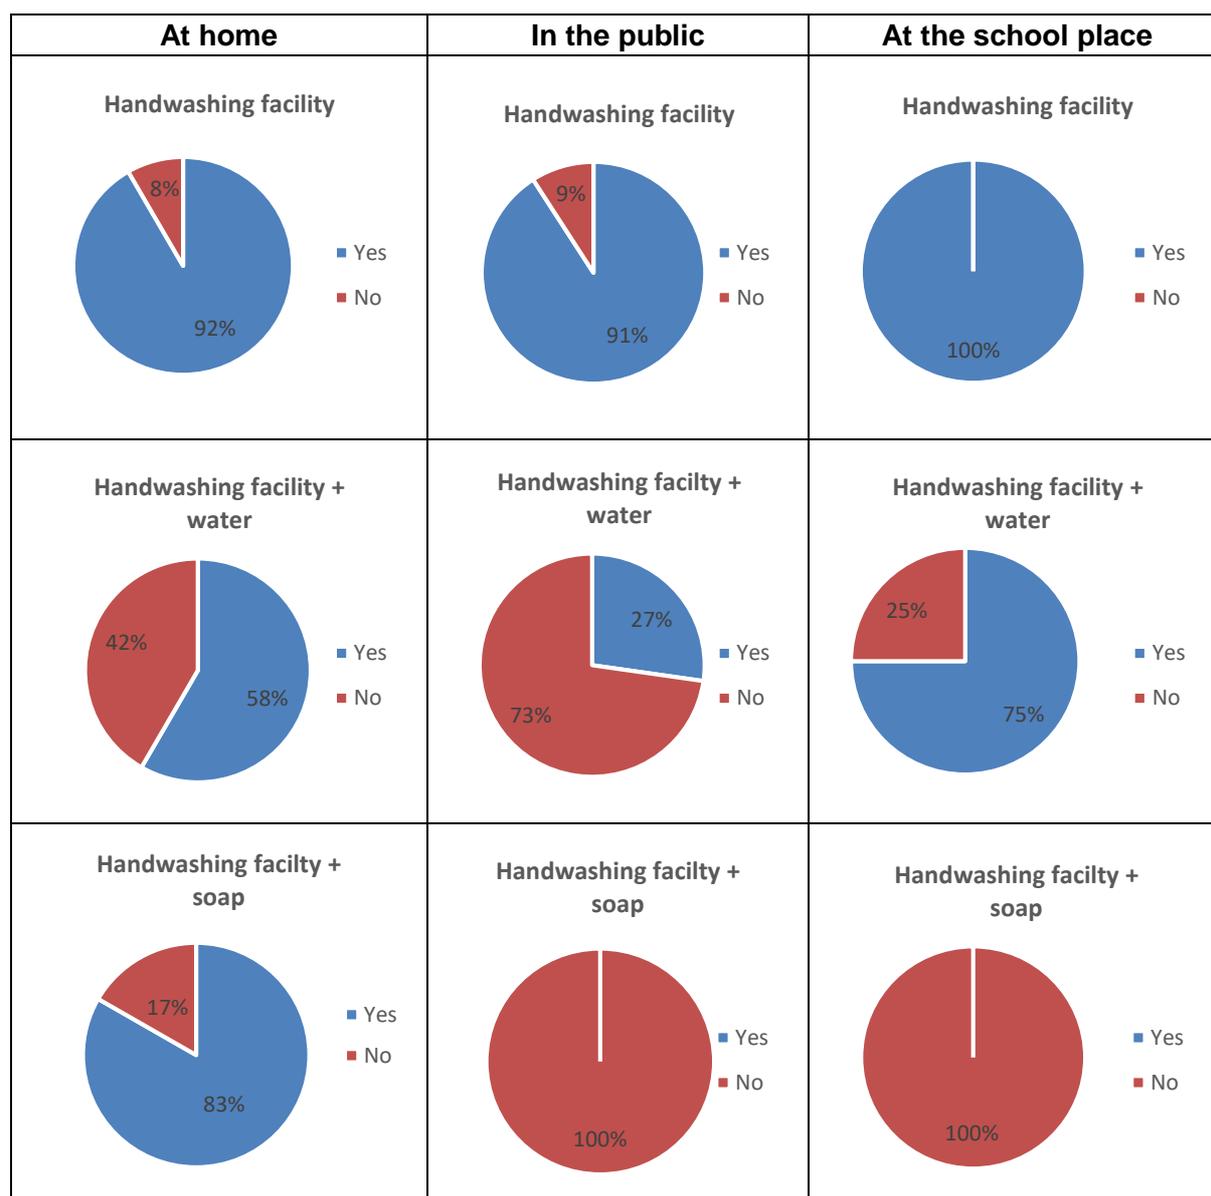
Figure 10: Results of the questionnaires on hygiene

The results of the questionnaires regarding handwashing facilities as well as the presence of water and soap are displayed in Figure 10. Looking closely at the results, at first glance they do not seem conclusive. For example, 91% of the students stated that there is a handwashing facility in the public toilet, and 9% of the students stated that there is none, all referring to the same public toilet. Similarly, there are different statements regarding the availability of water. This may be due to the fact that some handwashing facilities were connected to water and functioning and others were not. The results concerning the absence of soap is clear (0%). Concerning the school toilet, there are similar irregularities, 75% of the pupils state that water is available, 100% state handwashing facilities are present, and 100% state that soap is not present.

Looking at the results of the questionnaires regarding the conditions at home, 92% state a handwashing facility is present at home, 58% state the presence of a handwashing facility with water connection and 83% state the presence of a handwashing facility and soap.

Although the data are not statistically sound, they show a clear pattern. It is obvious that no soap is available neither in the public toilets nor at school. However, it is apparent that most students have a handwashing facility, water and soap at home.
